RE: Survey Report: Depth survey and sediment profiling of lake inputs, Lake Roaming Rock Reservoir.

EnviroScience, Inc. (ES) performed sediment accumulation surveys on Lake Roaming Rock in August and September of 2010. This report details the results of those survey efforts and data collections.

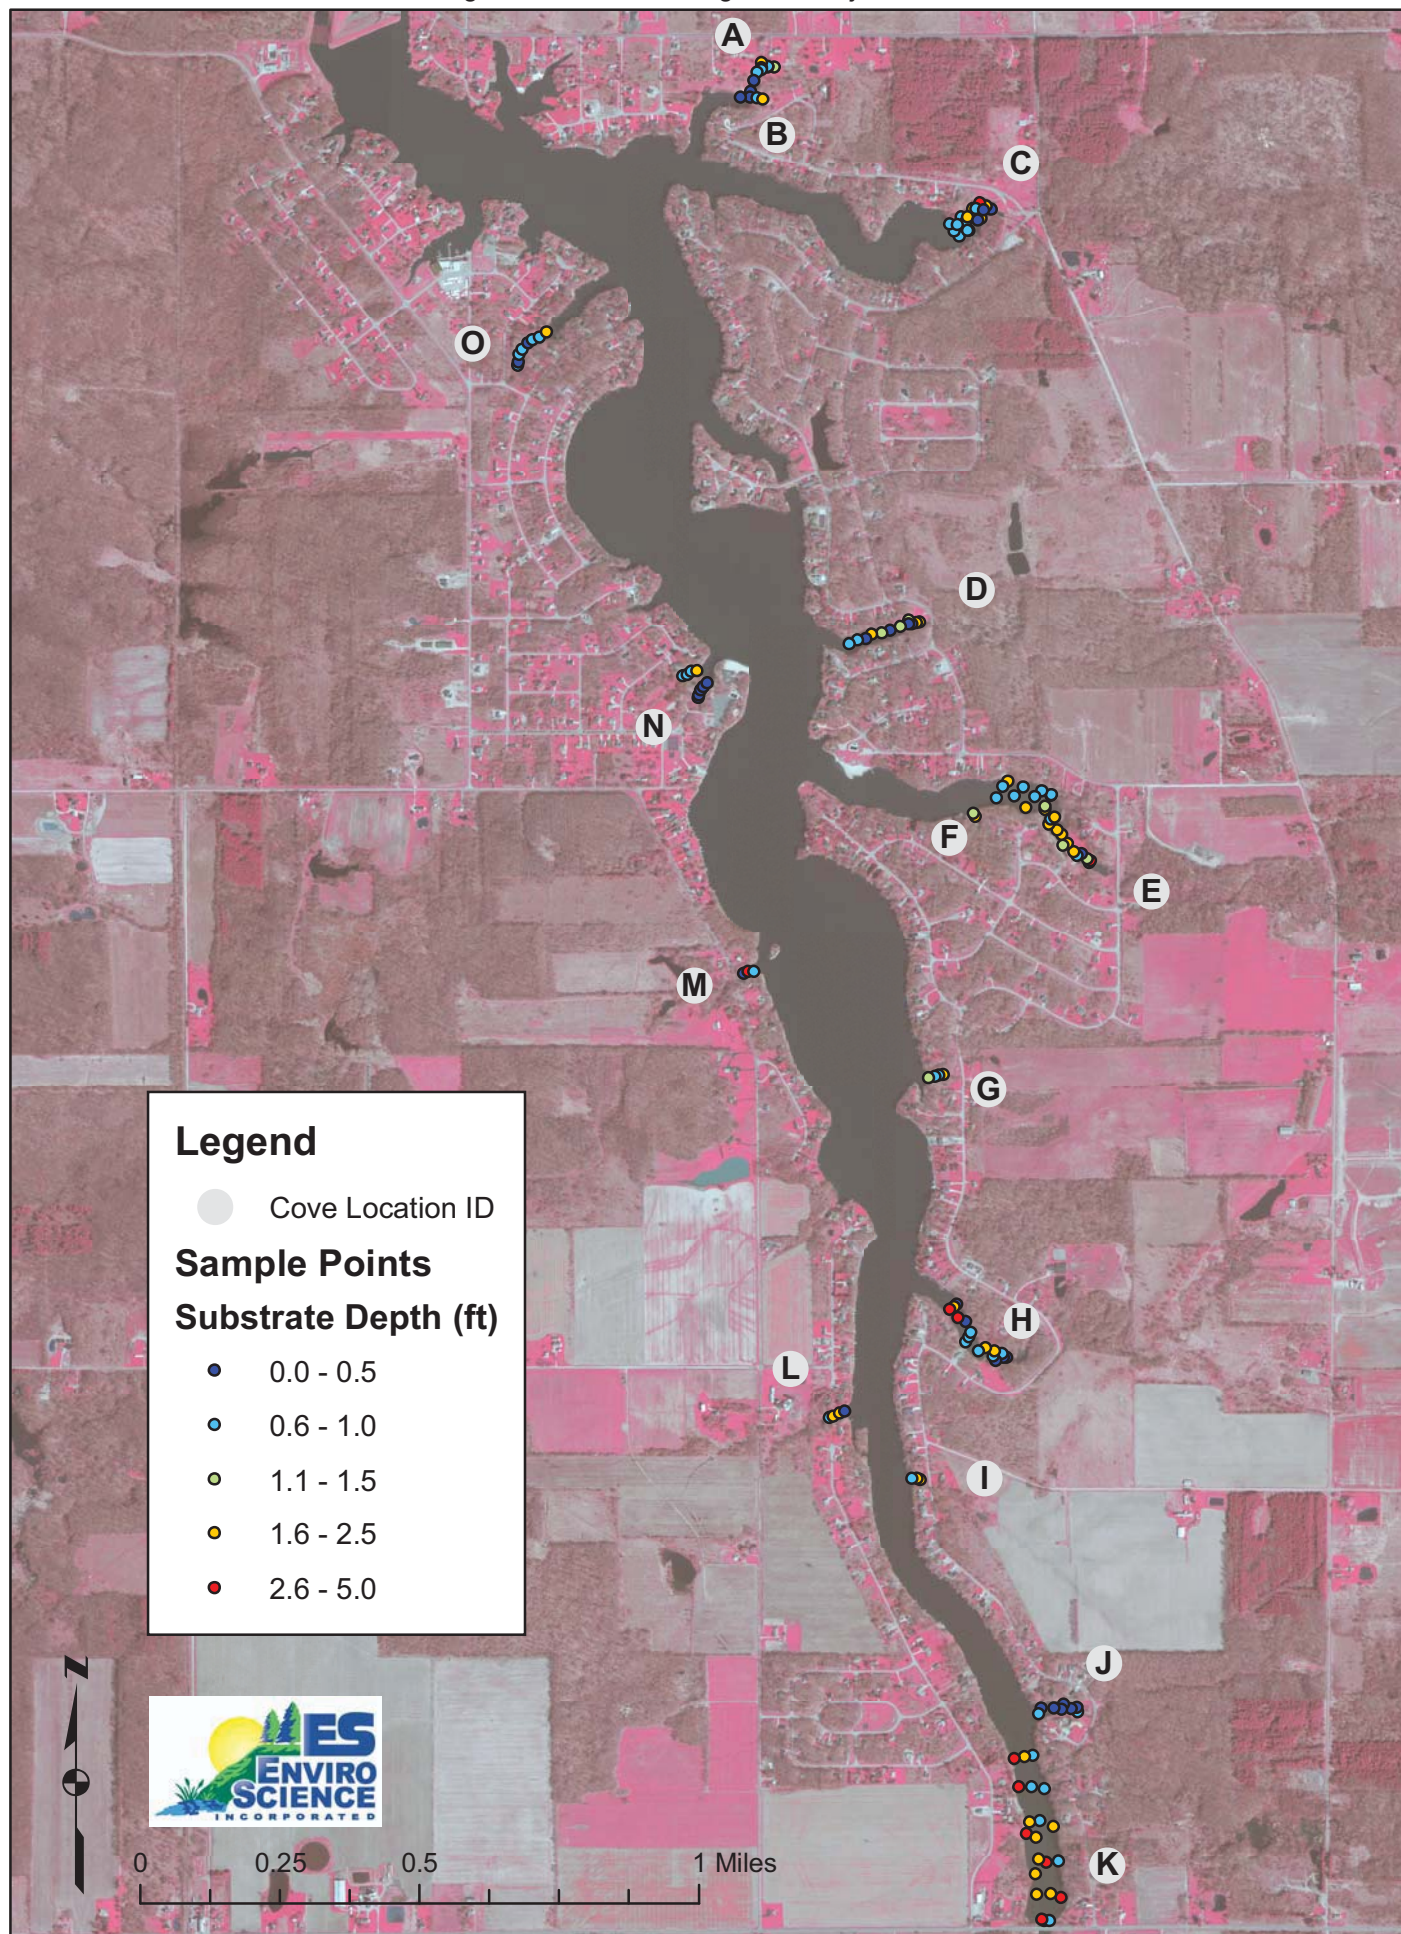
Figure 1. Lake Roaming Rock Project Area

ES conducted sediment and depth sampling on twelve (12) inlets on Lake Roaming Rock (Figure 1, Coves A - O). A first attempt used sonar to map sediments but this attempt was unsuccessful due to plant growth in the study areas and high water turbidity interfering with the sounder, as well as equipment malfunctions. A second survey was completed on September 2, 2010 using metered sounding rods. Sediment and depth surveys were completed from an ES work boat at no additional charge to RoamRock.

A total of 147 sediment / depth samples were collected from 12 coves within Lake Roaming Rock (Appendix A). Coves were labeled alphabetically from A to O beginning at the upper northeast corner of the reservoir and proceeding clockwise (Figure 1, Table 1). Cove "N" was subdivided into "Nn" and "Ns" to differentiate the north and south branches of the coves. ES conducted sediment and depth sampling on twelve (12) inlets on Lake Roaming Rock (Figure 1, Coves A - O).

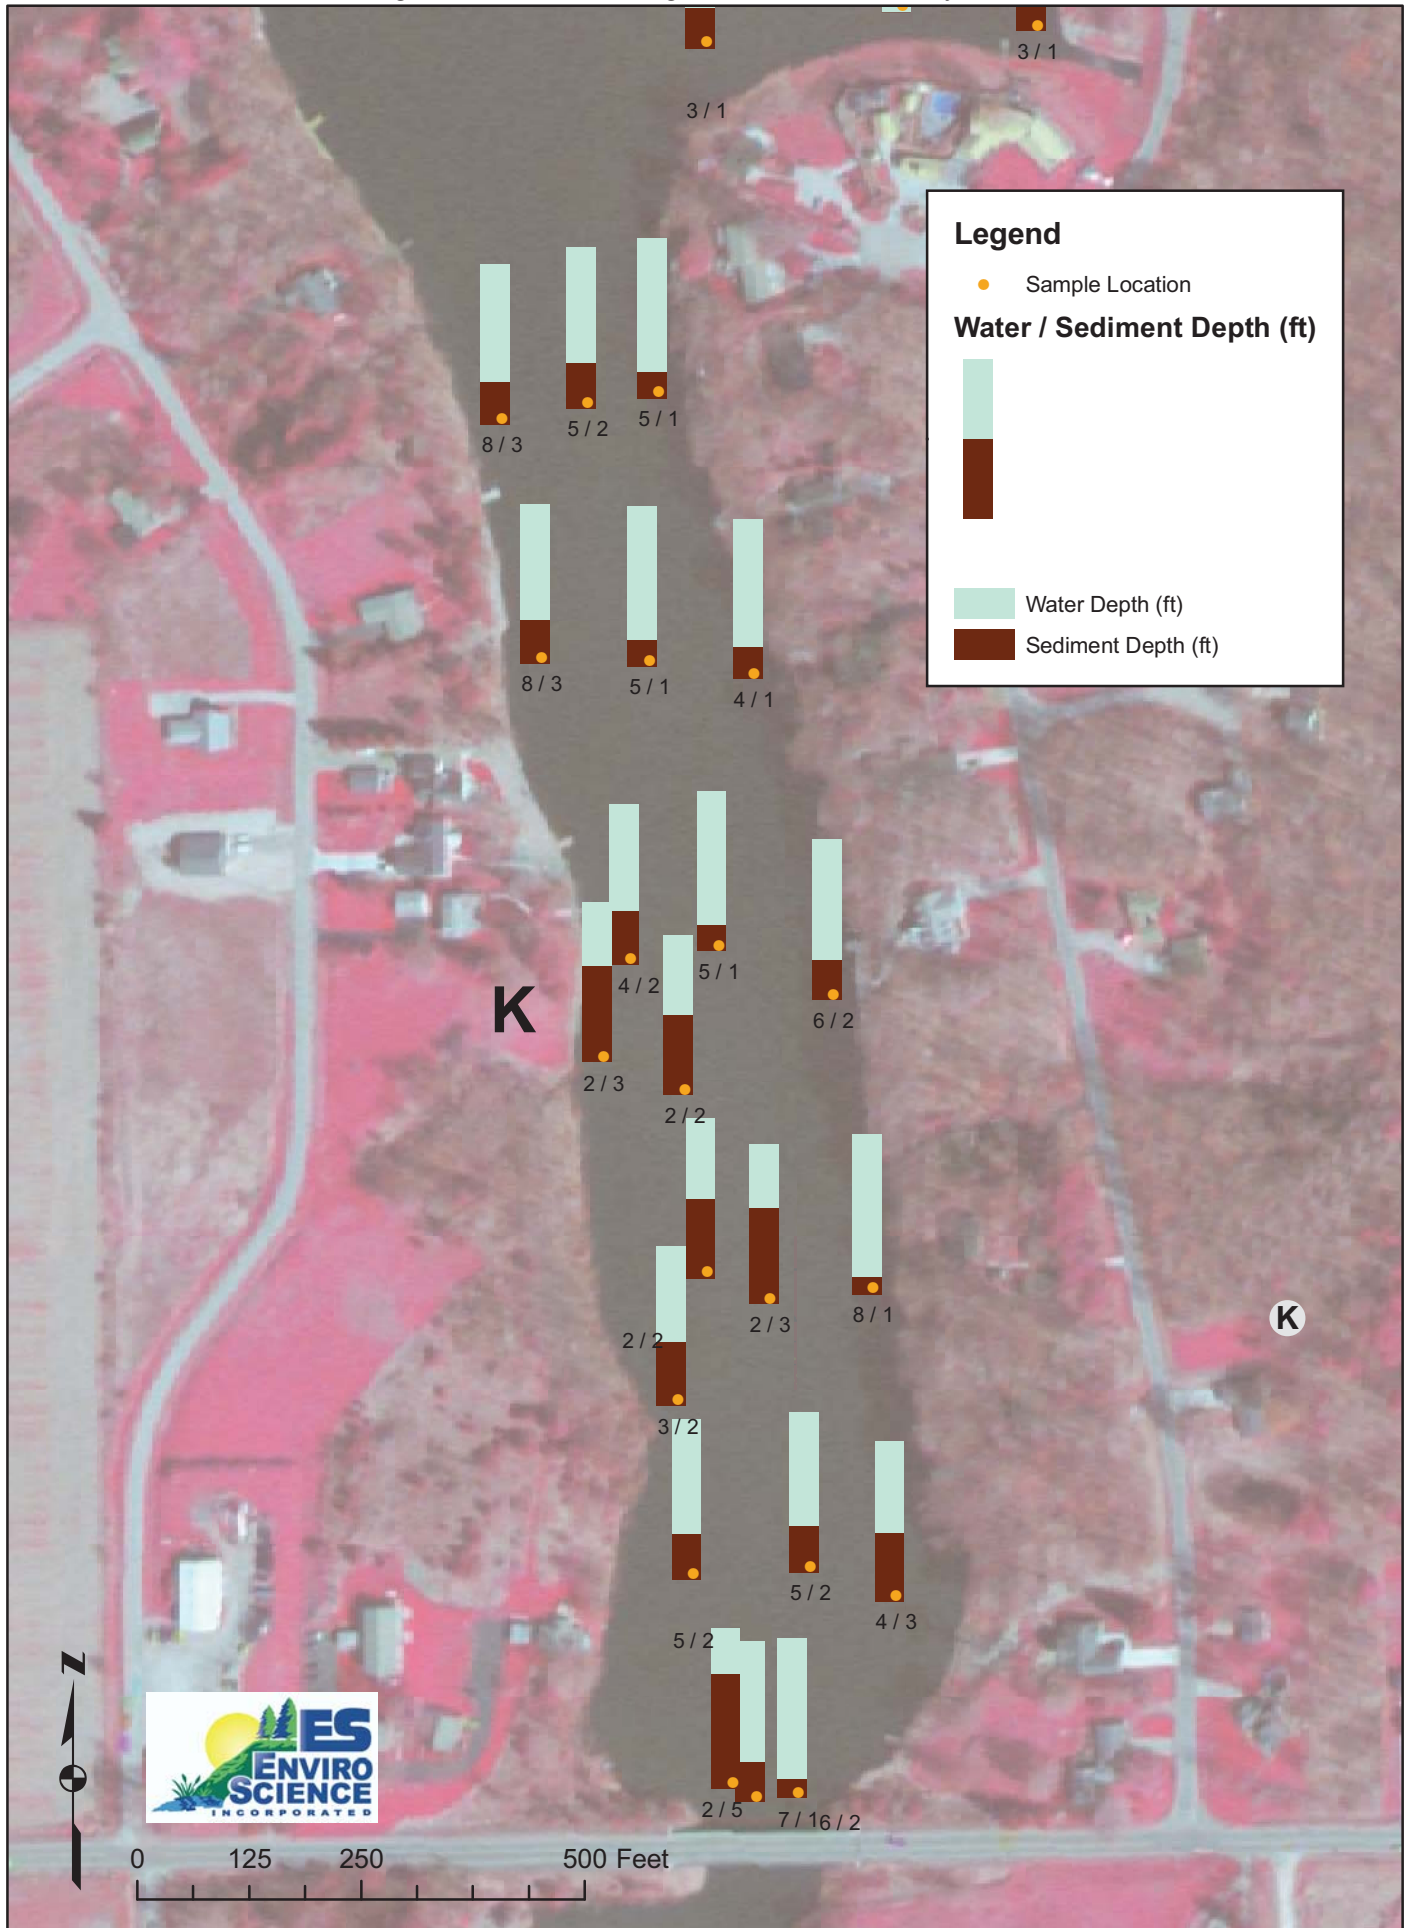
Figure 10. Lake Roaming Rock Sediment Survey: Cove K.

Cove K is where the main tributary of Lake Roaming Rock, Rock Creek, enters the reservoir and the where much of the sediment load of Rock Creek would be expected to drop out of the water column. Not surprisingly, an Island appears to be forming along the west side of the channel just north of G.A.R. Highway 6, with river depth two to three feet shallower than in 1978. This pattern of deposition is normal for a major reservoir input, and for this reason it was not considered a high priority concern.

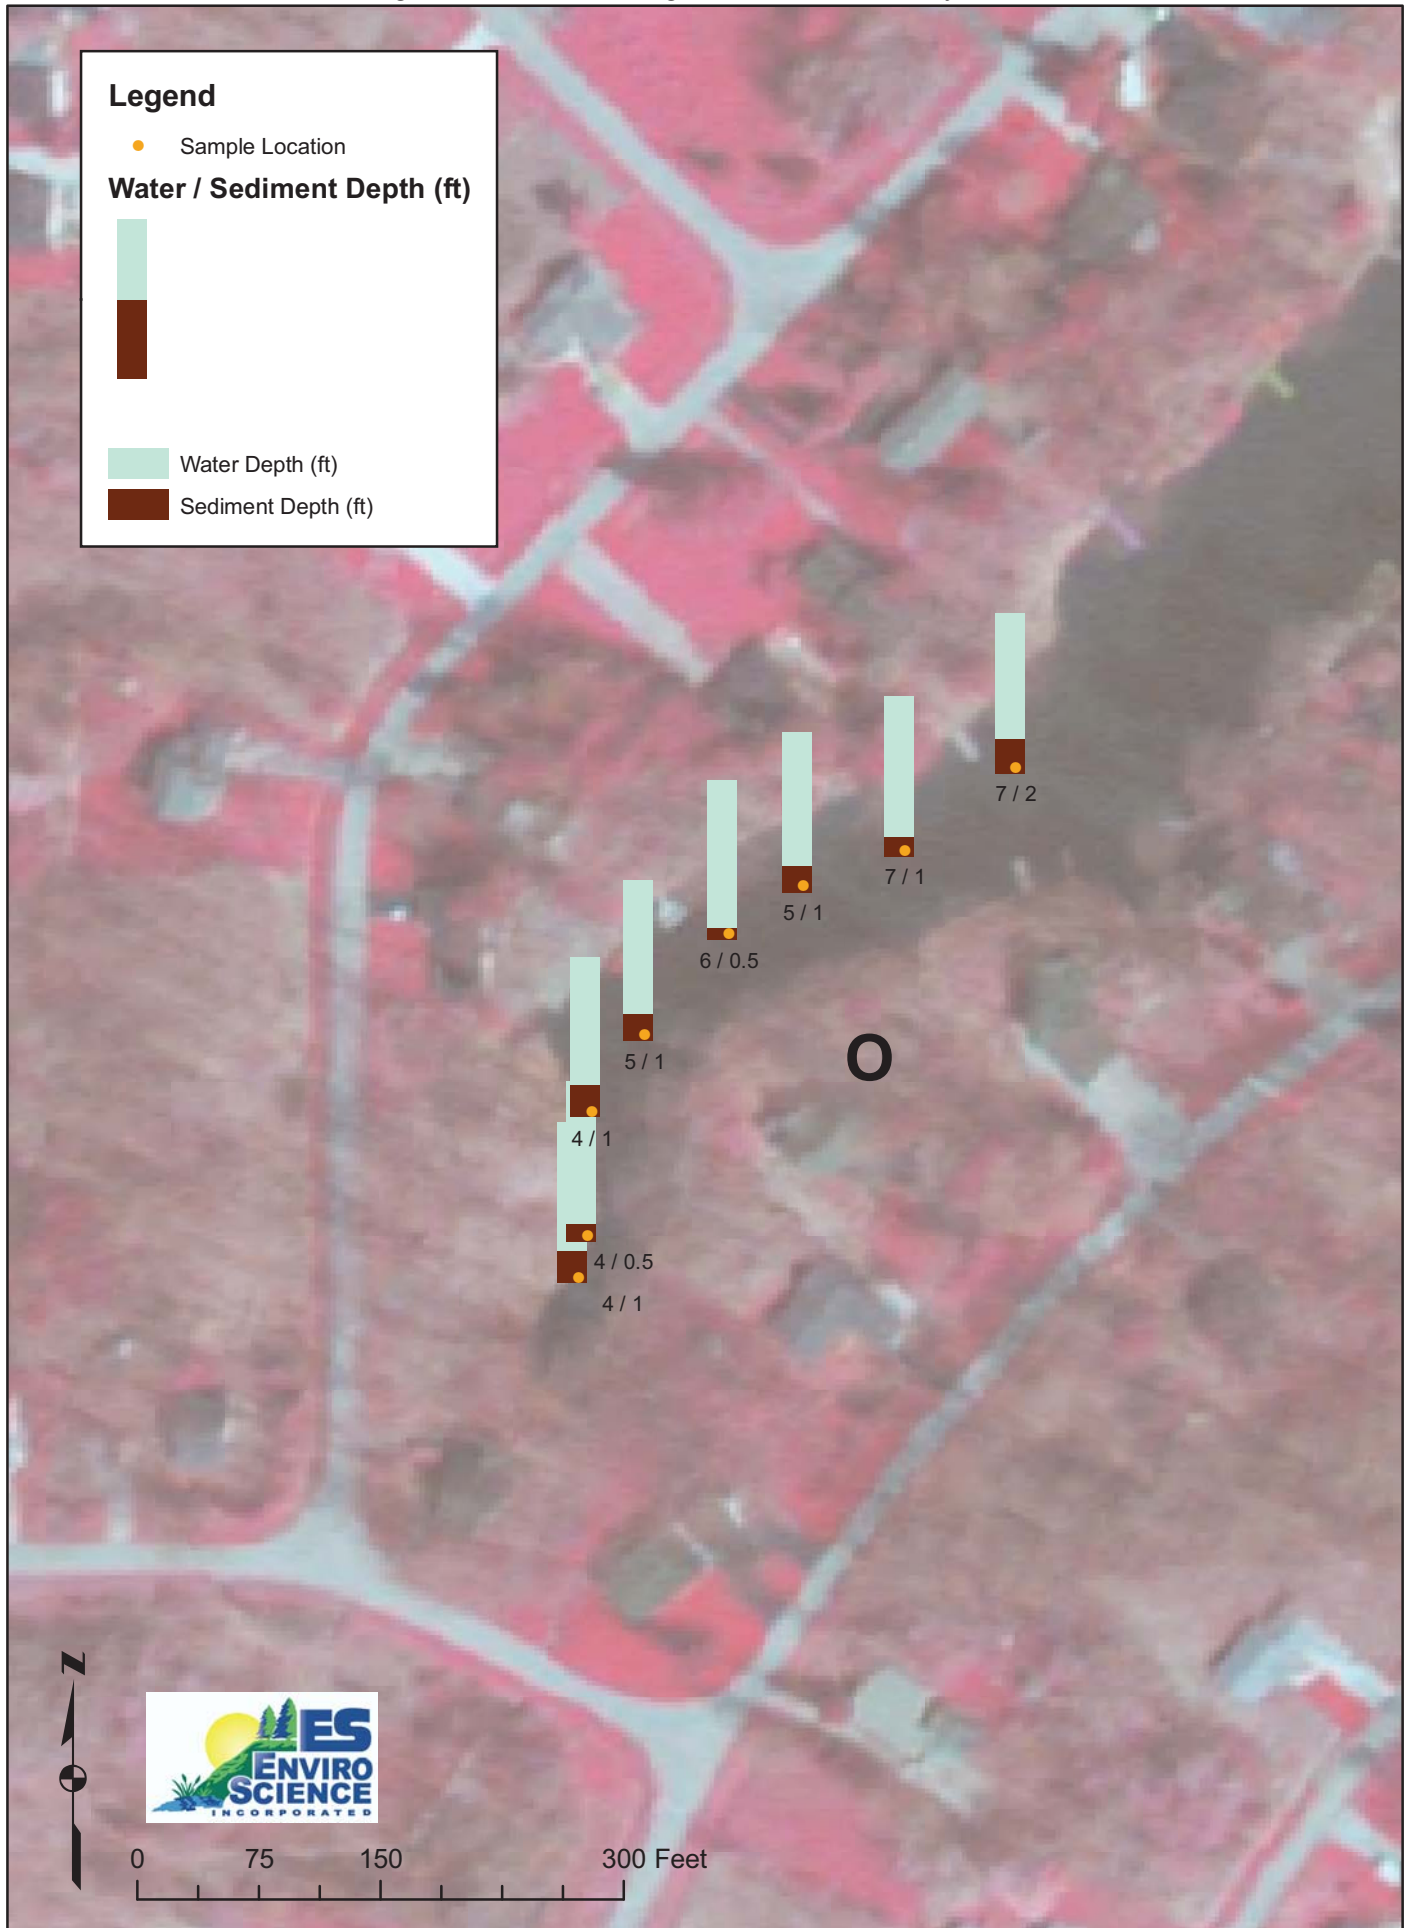
Figure 13. Lake Roaming Rock Sediment Survey: Cove O.

Cove O was relatively small and had a relatively small watershed compared to other coves. Sediment surveys did not detect a high level of deposition but comparison of 1978 and 2010 depths did show a two to three foot reduction in depth at the very end of the cove. This cove has a primarily residential watershed and this area could be assessed for potential sediment limits.

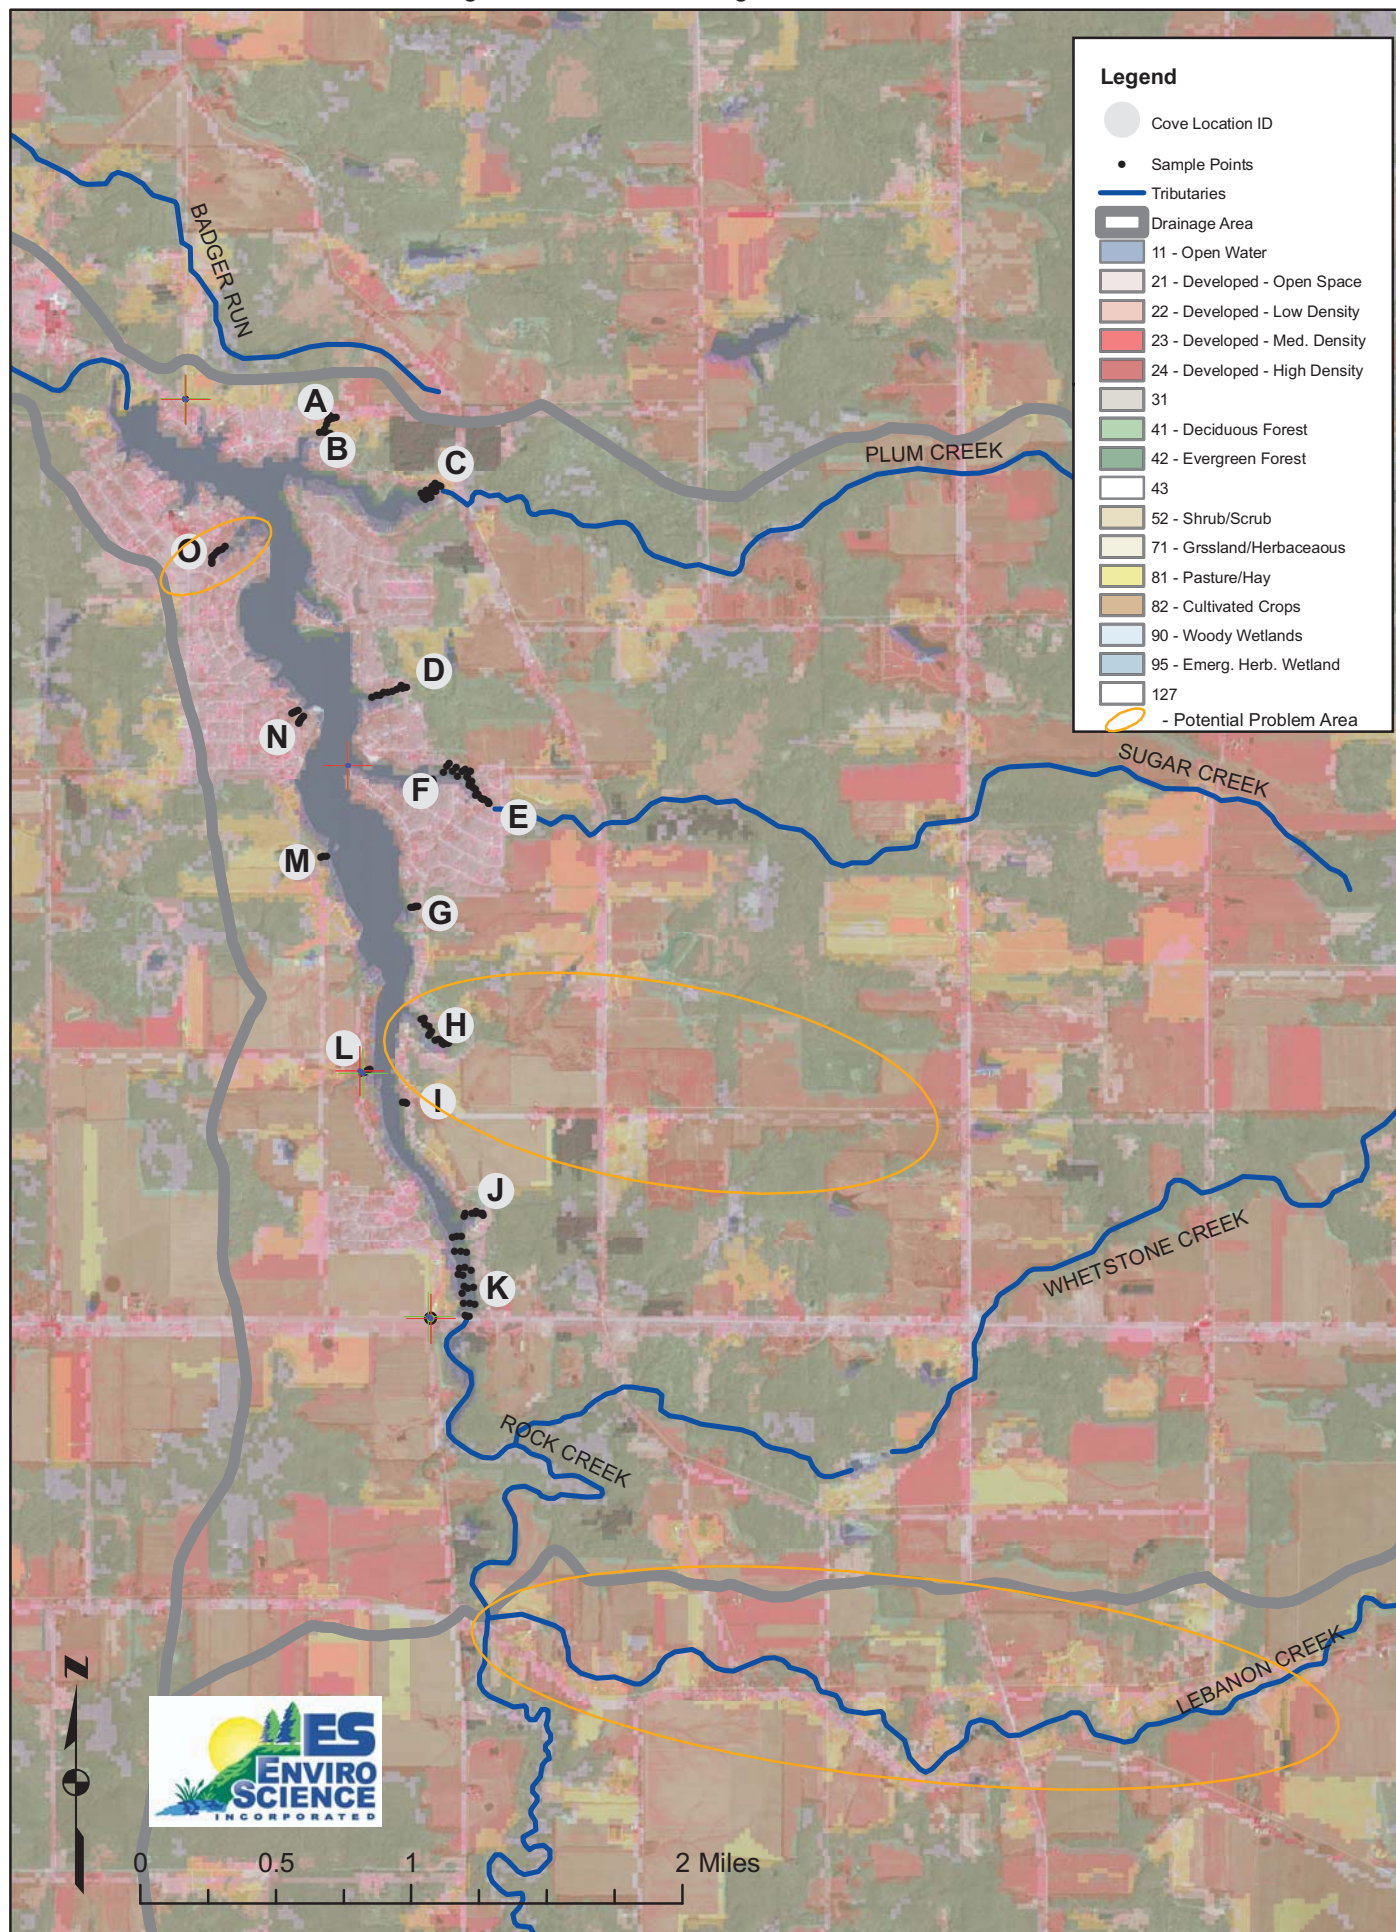
Figure 14. Lake Roaming Rock Watershed / Land Use

Cove H has a moderately sized watershed relative to some other coves which contain major tributaries. However this moderate watershed was found, based on a 2010 land cover survey (Figure 14), to consist primarily of cultivated crops, and possibly pasture. A review of aerial photography found that the drainageways coming from the cropland did not appear to have a good wooded or vegetative buffer, relative to other similarly-sized watersheds. While other coves may have had cultivated crops, the relatively small size of the Cove H watershed and its proximity to Lake Roaming Rock make it a good candidate for future restoration efforts.

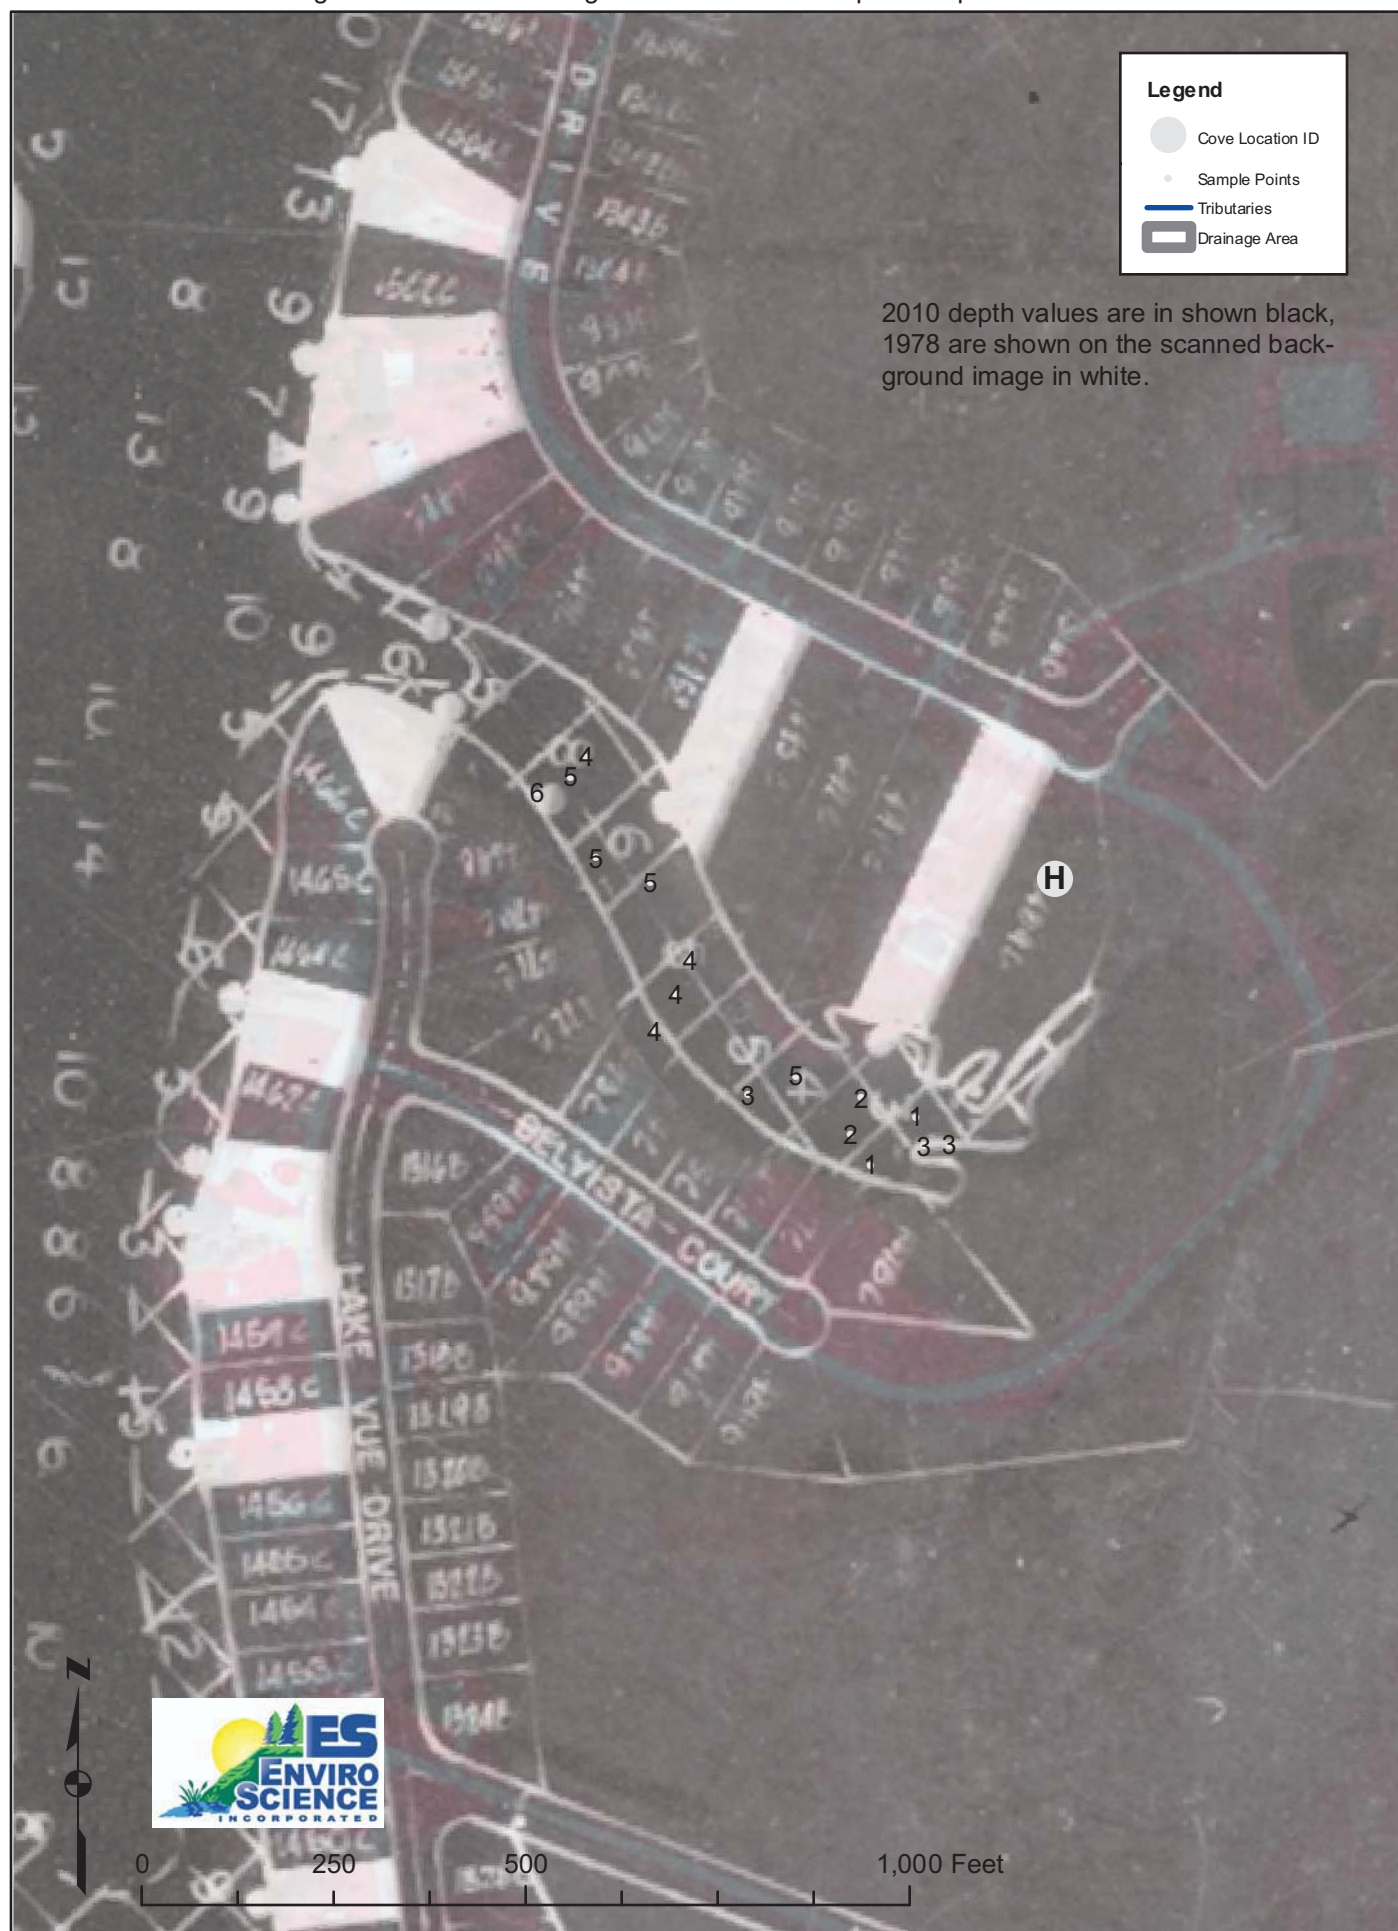
Figure 15. Lake Roaming Rock 1978 / 2010 Depth Comparison at Cove H

Overall, lake depths recorded in coves in 1978 showed little difference between 2010 data. Three moderate areas of concern were identified; Cove H, Cove K, and Cove O. Of these, Cove H and K were the primary area of concern, with consistent depth reductions of 1 to 3 feet since 1978. Otherwise, there was little difference found in depths of most coves between 1978 and 2010, however it is recognized that several of the coves have been partially or mostly dredged in recent years.

Lake Roaming Rock was found to have relatively little sedimentation over the 32 year investigative period (1978 – 2010) compared to other Ohio reservoirs based on ES's experience. A comparison of 1978 depth to 2010 depths found little changes, except as noted at Coves H, K, and O. Cove K sedimentation was expected because it receives the lake's primary tributary, Rock Creek. Cove H appeared to be the best candidate for watershed restoration or sedimentation controls because the watershed was relatively small. Lebanon Creek, a major upstream tributary of the lake, appeared to have an impaired watershed and Roam Rock may want to consider investigating restoration efforts in that area, such as teaming with a local watershed group to reduce nutrient and sediment inputs.
