**Lake Diagnostic Study
and Management Plan Development for
Lake Roaming Rock**

The RoamRock Association, Inc.

EnviroScience, Inc.

December 29, 2005

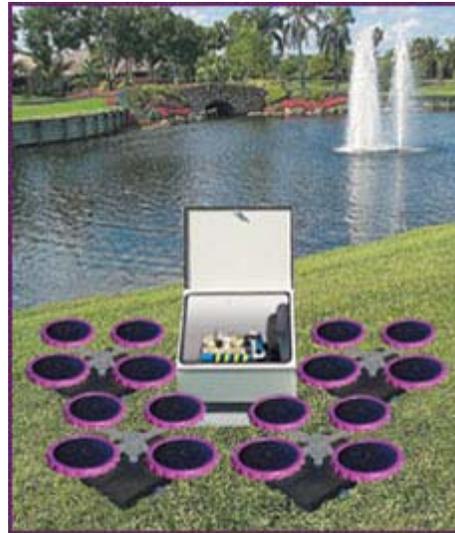
Conventional subsurface aeration systems typically utilize one or more shore-based compressors with air lines running out to devices called diffusers on the bottom of the lake. In general, an air flow rate of approximately 1.3 cubic feet per minute per acre is required to control algae and maintain a recommended minimum DO concentration of 5 ppm.

Figure 6-1. Aeration Diffusers and Compressor Assembly
(from Vertex Water Features, Deerfield Beach, FL). **Note:**
Fountain in background is a water feature unrelated to the aeration system shown in the foreground.

To be effective, aeration systems must be appropriately sized and powered. Systems with inadequate power may bring up nutrient-rich water without re-oxygenating the lake, resulting in algae becoming an even greater nuisance. Once begun, the system must be continuously operated. If turned off, algae may rapidly reappear because phosphorus will be rapidly released from the sediment under anoxic conditions. These systems can also be operated during the entire year to improve water quality. This type of system is considered safer than the other some floating aerators and fountains due to the fact no electrical cords are used in the water. A subsurface aeration system appropriately sized for Lake Roaming Rock is estimated to cost between \$200,000 and \$400,000.

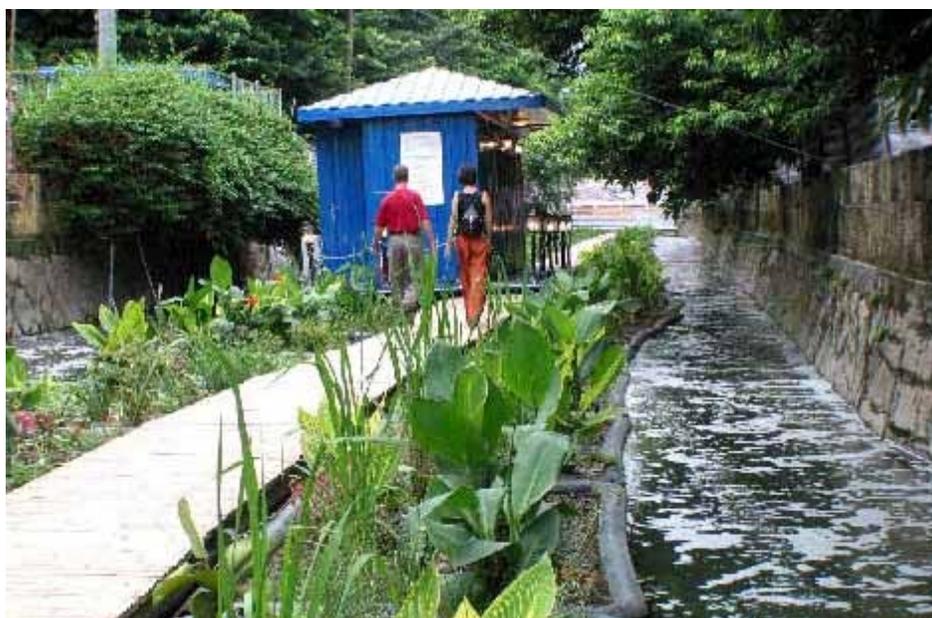
Physical Components and Systems

There are five basic physical components to Restorers: a floating structure, media to support attached growth bacterial communities, an aeration system, energy

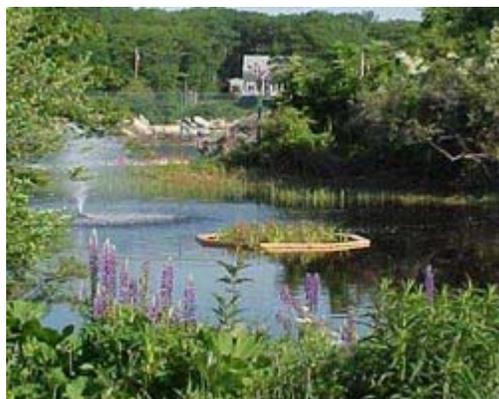
***Circular Restorer at Bush residence
in Kennebunkport.***

The concept of 'floating island' is visually apparent in this Restorer Design. HDPE cubes or pipes, some with wood frames, are used for structure. The HDPE provides long life and well tested floatation and strength for the process components of the Restorer. This configuration is typically square, rectangular or circular with dimensions of 15 ft to 30 ft (5 to 10 meters). Manufactured media is located in the center of the Restorer and plants are racked on the outside of the floating dock to a width of 5 ft to 10 ft (2 to 3 meters). Alternatively, fabric media hangs below the Restorer and plants are planted in the center. fueled by oxygen delivered to the
