2019 Aquatic Invasive Plant Survey at Lake Roaming Rock

Prepared for Lake Roaming Rock Board and Management Staff
Mark Warman, Aquatic Invasive Species Coordinator, Cleveland Metroparks

This report details the methods and results of an aquatic plant survey conducted at Lake Roaming Rock on June 17, 2019 by Cleveland Metroparks Aquatic Invasive Species Program. The project is funded by Ohio Department of Natural Resources (ODNR) via US Fish and Wildlife Service (USFWS) (F18AP00829) and support Aquatic Invasive Species (AIS) outreach, education, and detection in Ohio's Lake Erie Basin. Lake Roaming Rock is one of over 200 waterbodies assessed for aquatic invasive plants in Ohio's Lake Erie Basin.

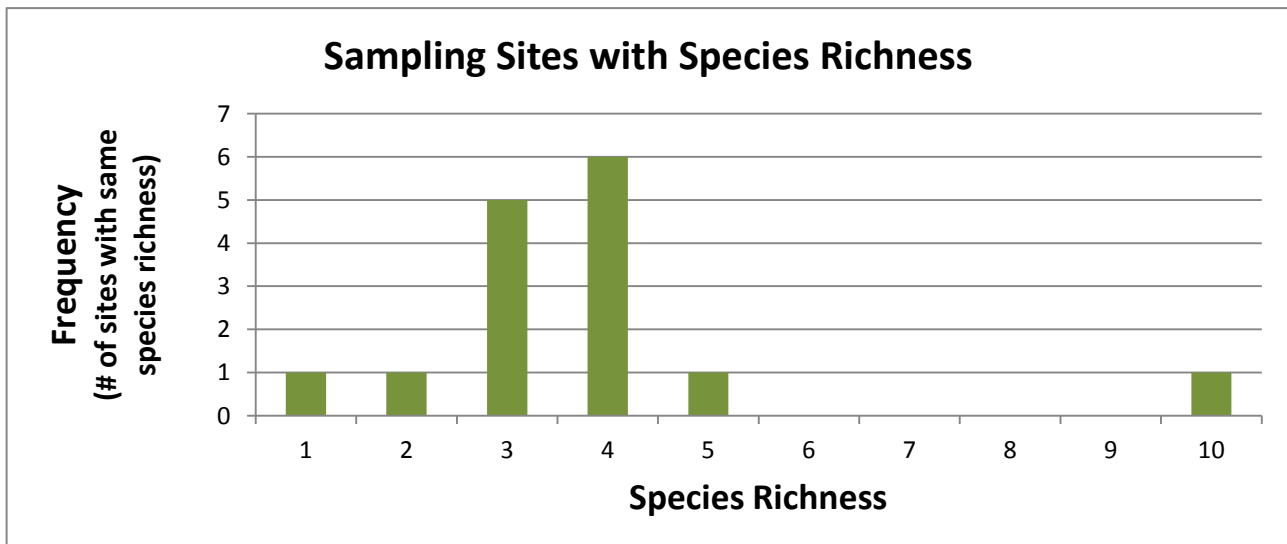
Figure 2. Frequency histogram showing the number of species collected at each of the 15 sampling sites (e.g. four different species were observed at six of the sample sites).

An average of 4.5 species were collected per sampling site. Two plants appeared with high frequency during the inventory, Eurasian water-milfoil (*Myriophyllum spicatum*) and Coontail (*Ceratophyllum demersum*), both at 14 of 15 locations. Both plants were dense at southern section of the lake. Lizard's tail (*Saururus cernuus*) was the only plant collected as fragments from the center of the lake. Aquatic plants were collected at 100% of the sample sites (15 of 15). The highest species richness for any single sampling location was at the Roaming Rock Marina, where 10 species were collected (Figure 2). June 17 is early in the growing season and it is probable that a survey later in the season would result in higher densities and increased diversity of plants throughout the lake.

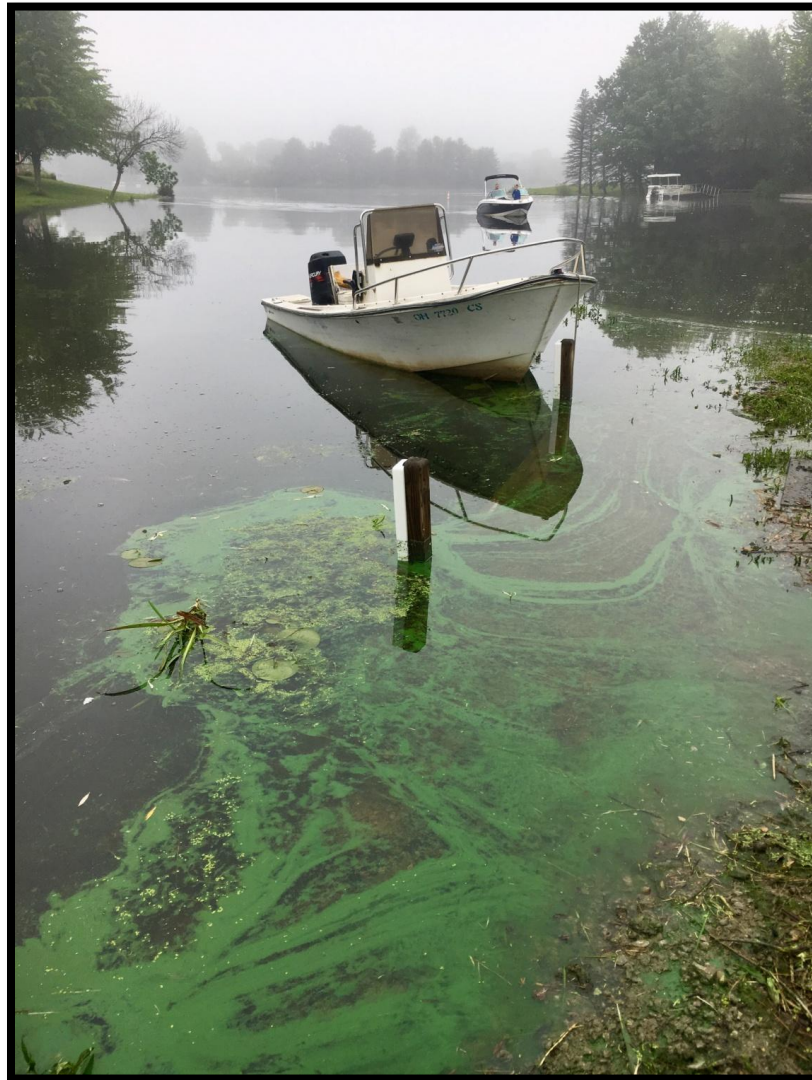
Figure 3. Algal growth, species unknown, at Lake Roaming Rock near the marina. Photo, Rachel Nypaver.

In general, “Lakes in watersheds dominated by row cropping have systematically high nitrogen and phosphorous” (Arbuckle, Downing 2001). The watershed of Lake Roaming Rock is 73.5 square miles, with a large percentage of agricultural row cropping. There will be an ongoing input of nitrogen and phosphorous from the watershed into Lake Roaming Rock, which can induce growth of aquatic plants and algae, Figure 3.

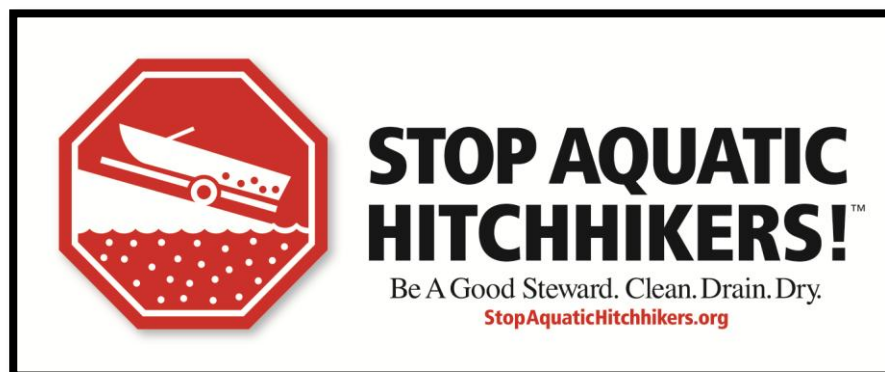
Figures 4. Example of Aquatic Invasive Species signage.

- Display invasive species awareness signage, such as Stop Aquatic Hitchhikers, to educate recreational boaters at the boat ramp and marina. Consider the addition of disposal stations to facilitate disposal of plants and unused boat, Figures 4 & 5.

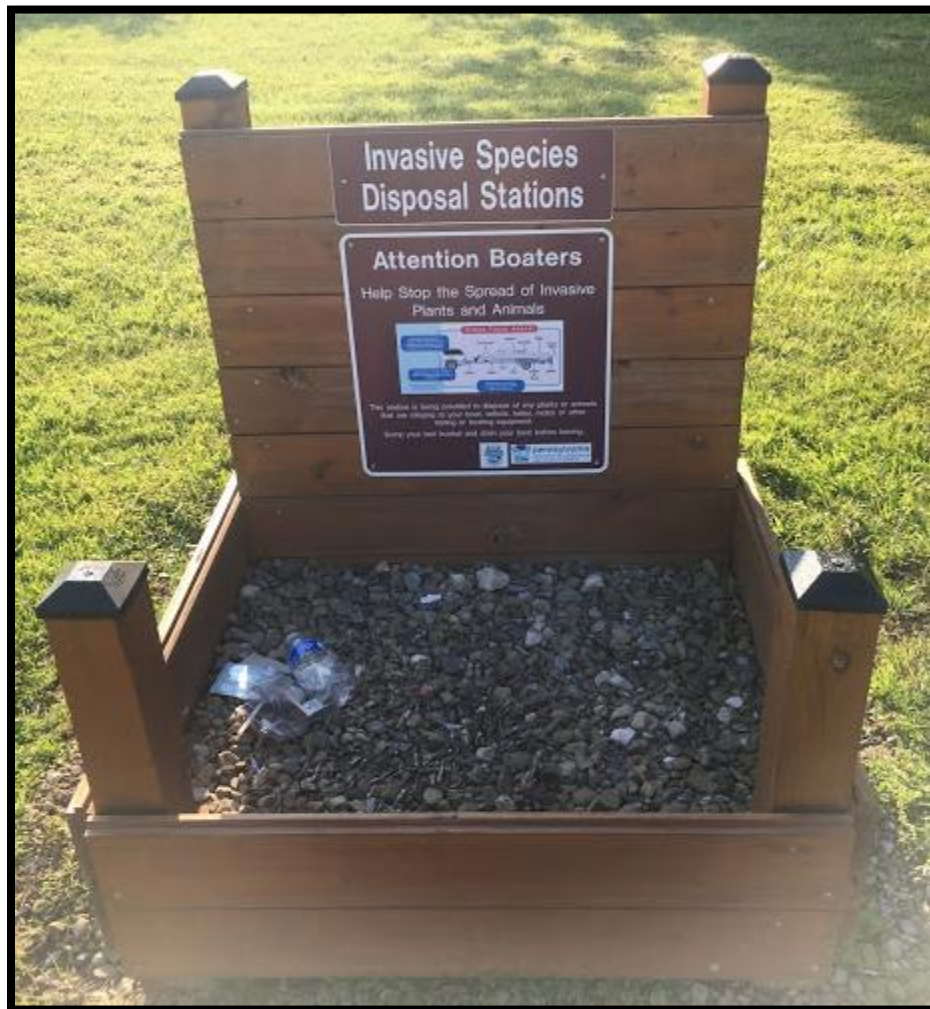
Figure 5. Disposal station at Pymatuning State Park.
